The Daily Star

The heart of the matter: ineffectual, ineffective and inadequate

Core of high-rise buildings of Dhaka city

Study of the heart (core)of high-rise commercial buildings

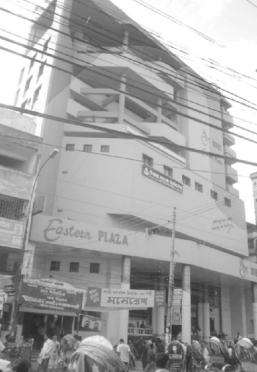
Core 1 and 2 are accessible from the main entry. Core 1 is for shopping complex and core 2 is for office floors. In core 4 the lifts reach up to 4th floor and the staircase extends to top floor. In 3, there is only a staircase which starts from the basement and reaches the 4th floor and again starts from the fifth floor and reaches the top floor. Lighting and ventilation

All the cores are well lighted except core 2. Core 2,4 and half of the core 3 are air conditioned and mechanically ventilated. Core 1 and all the staircases for office floors are naturally ventilated.

Fire escapes and fire fighting Though Eastern Plaza was a milestone in shopping complex designing, it can become a fire trap for various reasons. According to building construction rule 1996, there must be emergency exit not more than 25m. from any point of a floor area and it must be connected with the ground floor and separated from lift and main stair lobby. Moreover fire exit should not reach to the basement floor. In Eastern Plaza the stairs are more than 50m. away from each other, two stairs go to basement (No 1 & 3). Only stair of the core 4 is suitable as fire exit as it is controlled by a door. In the office floors the case is more severe. There are only 3 stairs in which stair No 3 is ends in the fifth floor. Staircases in core 4 is locked with collapsible gates. Again hose pipes are abandoned, have no water supply. In case of fire hazards one has to reach to core 1's staircase which will take him to the ground floor. If fire hazards occurs in place (a) and (b) one may get trapped.

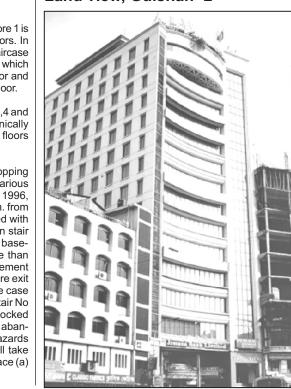
Land view, Gulshan -2

Core Study: Lift size: 6' x 4' Lift lobby: 10' x 13' Nos. of lift.: 2 Stair: Width: 6' Lighting condition: Satisfactory. Positive Issues: - Core with sufficient natural lighting. - Clearance in front of lift cars is satisfactory. - Having fire exit provision. - Fire fighting systems are identical. - Fire extinguisher, fire alarm, smoke detector, smashed switch and hosepipe for fire prevention are present in each floor. Display panel to identify the fire affected floor and also one master fire alarm is present. Negative Issues: - The core is placed at south facade. - The fire exit is not easily accessible. [Disregarding BNBC 3.4.11 - No marks and sign posts to indicate fire exist from corridors and passages. [Disregarding BNBC 3.3.4]

- Fire exit leads to the basement of the building. [Disregarding BNBC 3.4.5]

- Door swing of the fire escape is towards the lobby, this could cause problem in fire hazardous situation. [Disregarding BNBC 3.9.5]

Size of the inside lift area does not satisfy stretcher facility. [Not following BNBC 5.2.1.2 (a) (b)] - Has no garbage chute.

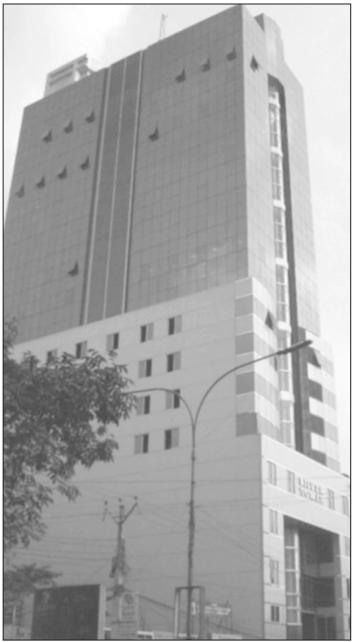
Silver Tower, Gulshan circle one

Floor	:	20 nos	entr
No. of lift	:	2 main lifts & 1	No f
capsule lift			core
No Stair	:	one	No
Fire stair	:	main stair	stair
used as fire escape			Mair
Capsule li	ftisio	ocated at main	vent

entry which is not a good location at the time of fire hazard .Core is not easily visible from the main liaht

r to lift core n stair is naturally lighted and tilated but it is not easily visible. Difficult to find the lift from the main entry because of lack of natural

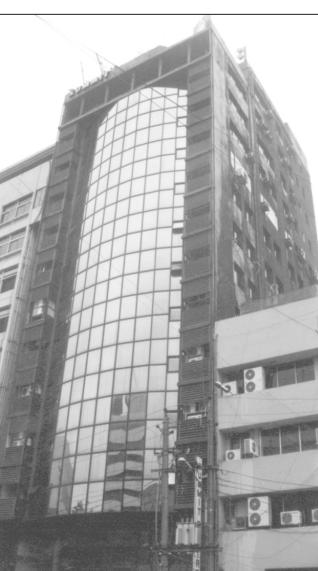
day: About 2000 Lighting condition: Ventilation: Up to 9th floor -- naturally ventilated; from 10th to 17th floor -- centrally air conditioned Fire protection measures according to standards for high rise buildings Observations 01. Although people from a building attacked by fire have to escape within 2.5 minutes, and 40 persons can escape in one minute through a 22-inch wide opening, the main staircase is only 3' wide and the 20inch wide stair dedi-

cated to Fire Escape is not adequate for 1500 persons using this building at any given time. Employees and visitors alike will be trapped.

02. Access to the staircase should be through a room(fire lobby) which is mechanically under compression but no such provision has been made here. 03. Door of fire lobby has to be properly enclosed by a fire door but the

staircase in this building is not properly enclosed 04. The direction of door opening should be towards escape but in this

ouilding it is against the escape. 05. Doors in the escape route have to be of fire resisting materials but in this building they are made of mineral board.

06. Fire escape has to be in normal usage but here it is abandoned and also blocked.

07. The position of fire escape has to be in an easily accessible place but this is not the case in this building.

08. Fire escape must exist within 25m (82 feet) from any point on a floor out this rule has not been followed.

09. Main floor staircase cannot continue to the basement but both the cases continue up to the basemen
