## A landmark in despair

The Parir Pahar (Fairy's Hill) is one such high site, on which sits the Chittagong Court Building. It is the largest single building atop a hill before Bengal was divided. The British purchased the 25-acre property of hill and valley from Zamindar Alik Chandra Sen and built the two storied red brick building in 1892/98. The site had two large water bodies in the northern valley for a park (later filled for a hawkers market). The building was surrounded by open park spaces with public access. It was a favourite spot of city dwellers and tourists to look down and have a comprehensive view of the town below, the river, hills and plains beyond, thus satisfying a natural human instinct to survey one's own

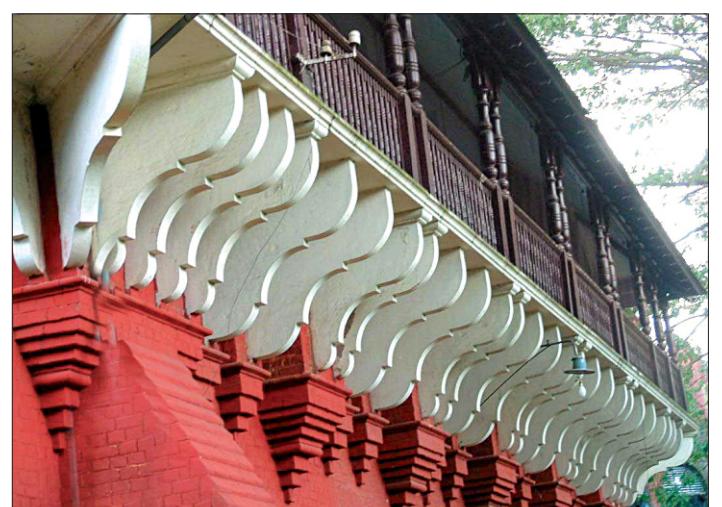
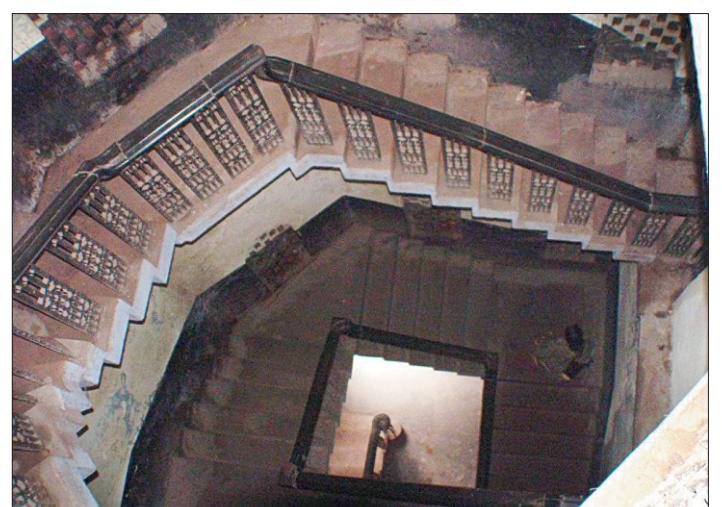
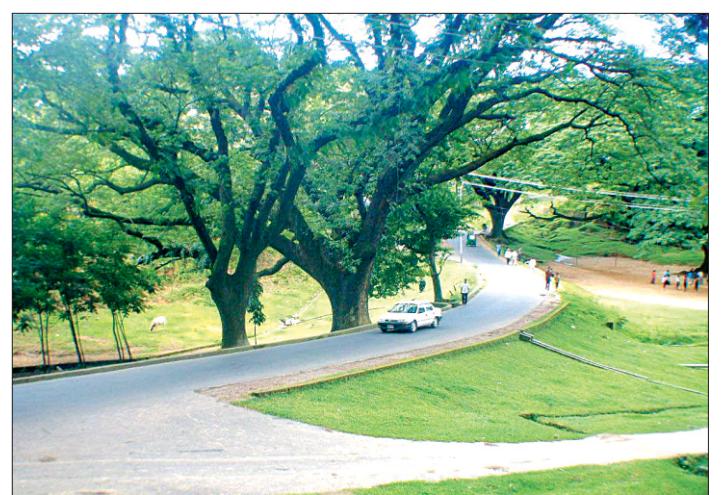
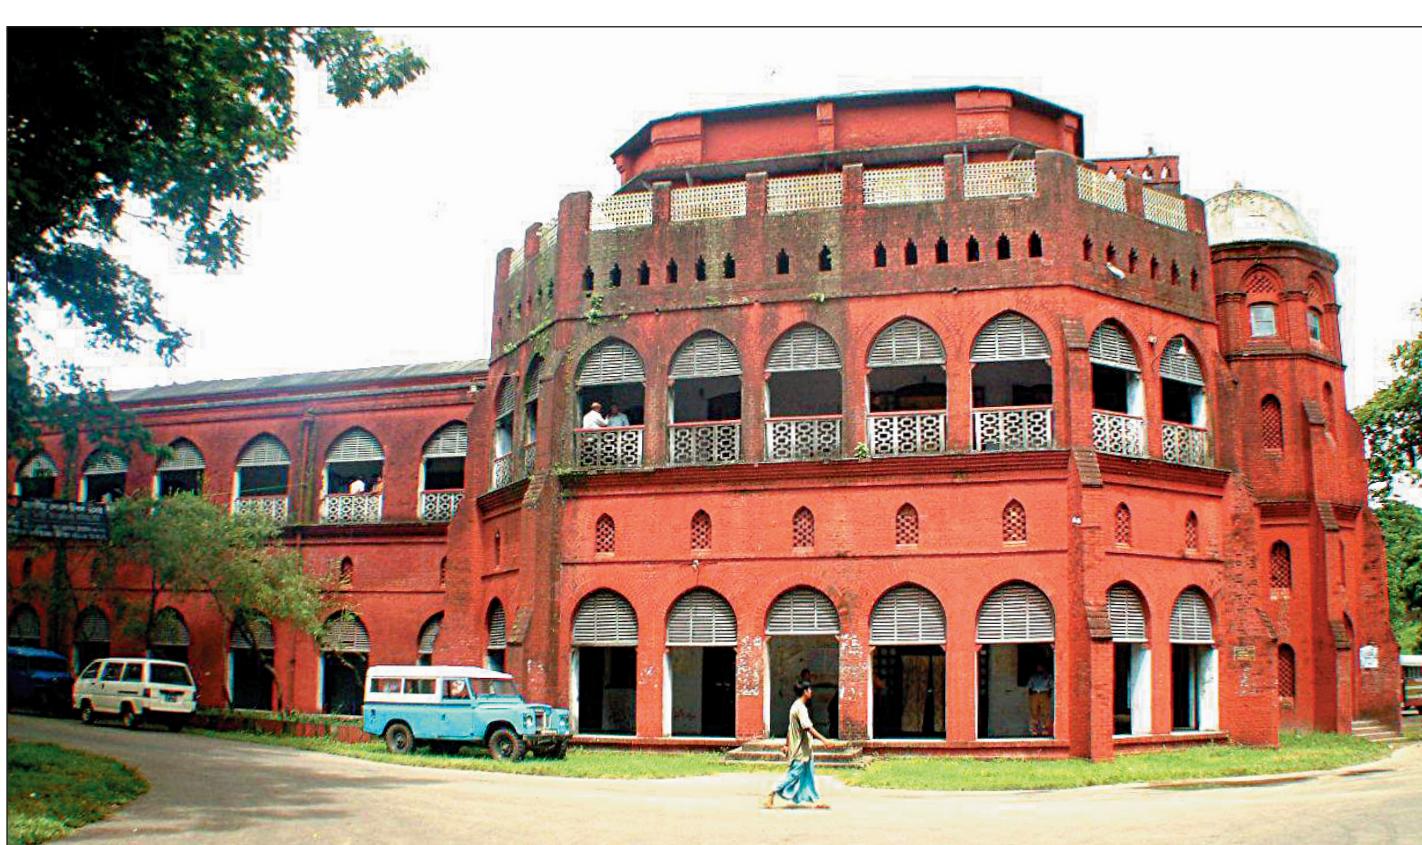
The Building is in a state of neglect and unattended. Fungus has covered northern walls; leakages from pipes have caused dampness to the wall surfaces in some parts. The most damage has been caused to the corridor floors in the north and south. Rainwater seeping through the sandstone floor tile joints and the limestone surface has corroded the iron ribs and joists below, in some sections. The main wooden staircase has been damaged with overuse and neglect and the cast iron railings are missing in many parts. A Court Order has been passed to the authorities to maintain the building.

Conservation of buildings and sites is little understood and less valued. It is important to establish a mechanism for this activity - one that works. To uphold our image as a nation with a cultural and historic past, and to promote tourism conservation and preservation of History and Heritage must form a routine exercise of the normal planning and development activity within Development Authorities and Municipal Bodies. Conservation of the Chittagong Court Building and many other such landmarks must be saved for our future generations.
