## Trembling in apprehension

## Earthquake risk in Bangladesh: Facing the reality

DR. TAHMEED M. AL-HUSSAINI

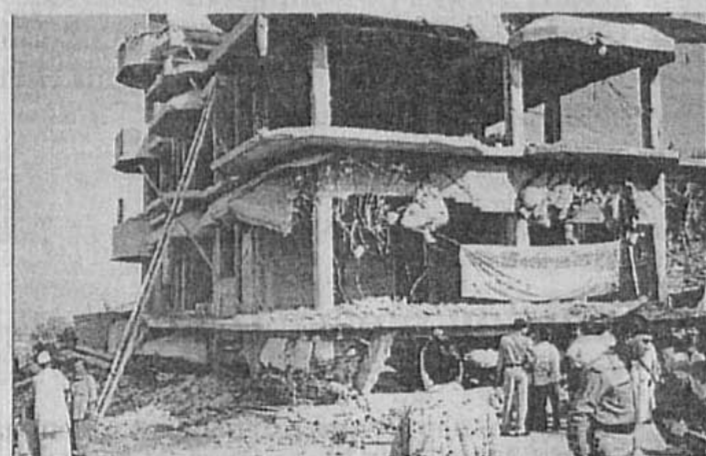
Collapse of under-construction multi-storied building in Chittagong due to Nov. 21, 1997 earthquake at Bangladesh-Myanmar border

earthquakes. Some of the photographs taken by the writer are presented which show the damage caused by these earthquakes. Fig 1 shows the collapse of an under-construction reinforced concrete frame building that killed several people in the port city of Chittagong due to the Nov. 21, 1997 magnitude 6.0 earthquake at the Bangladesh-Myanmar border. This is a typical example of faulty design and construction, collapse occurring at a very low level of shaking, about 100 km from the epicenter of the earthquake. This earthquake also caused some cracks in some buildings and walls in the Chittagong and Bandarban region, and collapse of a portion of an under-construction earthen dam. The July 22, 1999 magnitude 5.1 earthquake with its epicenter very near the island of Moheshkhali, off the coast of the tourist spot of Cox's Bazar, caused extensive damage and collapse of rural mud-walled houses. This earthquake exposed the vulnerability of mud-walled houses, which is quite common in many parts of rural Bangladesh. Cracks and spalling of plaster were observed in some buildings. Concrete column of a cyclone shelter was severely damaged (Fig 2). Soon after the July 27, 2003 magnitude 5.6 Barkal-Rangamati earthquake, the writer visited Rangamati and the badly affected village of Kolabunia, Barkal Upazilla, which is about one and half hour journey by speed boat from Rangamati. Brick masonry buildings of Kolabunia suffered severe damage, brick boundary wall collapsed, and several mud-walled houses were subjected to severe damage to partial-collapse of its walls. Large crack developed for a long distance along the river, indicative of soil movement toward the river. Slumping of part of the river bank also occurred at one place. Local people reported emission of bubbles in the river during an aftershock. Fig 3 shows a long school building in Rangamati that developed crack in its wall, while Figs 4 to 6 present damage in Kolabunia. In Chittagong city, about 90 km away from the epicenter, the earthquake caused ground settlement and cracks (Fig 7) in the Public Library building and damaged an electric transformer. In addition, minor earthquakes are frequently occurring in the Chittagong area causing a good deal of anxiety among the people there.

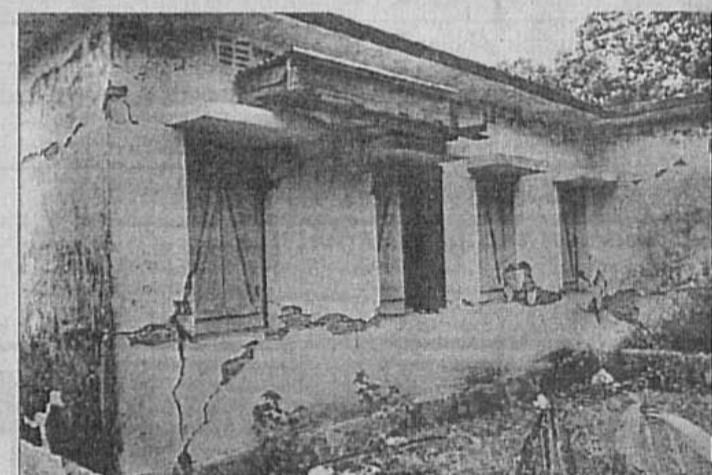
Severe damage to brick masonry building in Kolabunia during July 2003 Rangamati-Barkal earthquake.
